Debris/Ice/TPS Assessment And Photographic Analysis For Shuttle Mission STS-35

Gregory N. Katnik
NASA/Kennedy Space Center

DEBRIS/ICE/TPS ASSESSMENT
AND
PHOTOGRAPHIC ANALYSIS
OF
SHUTTLE MISSION STS-35

December 2, 1990

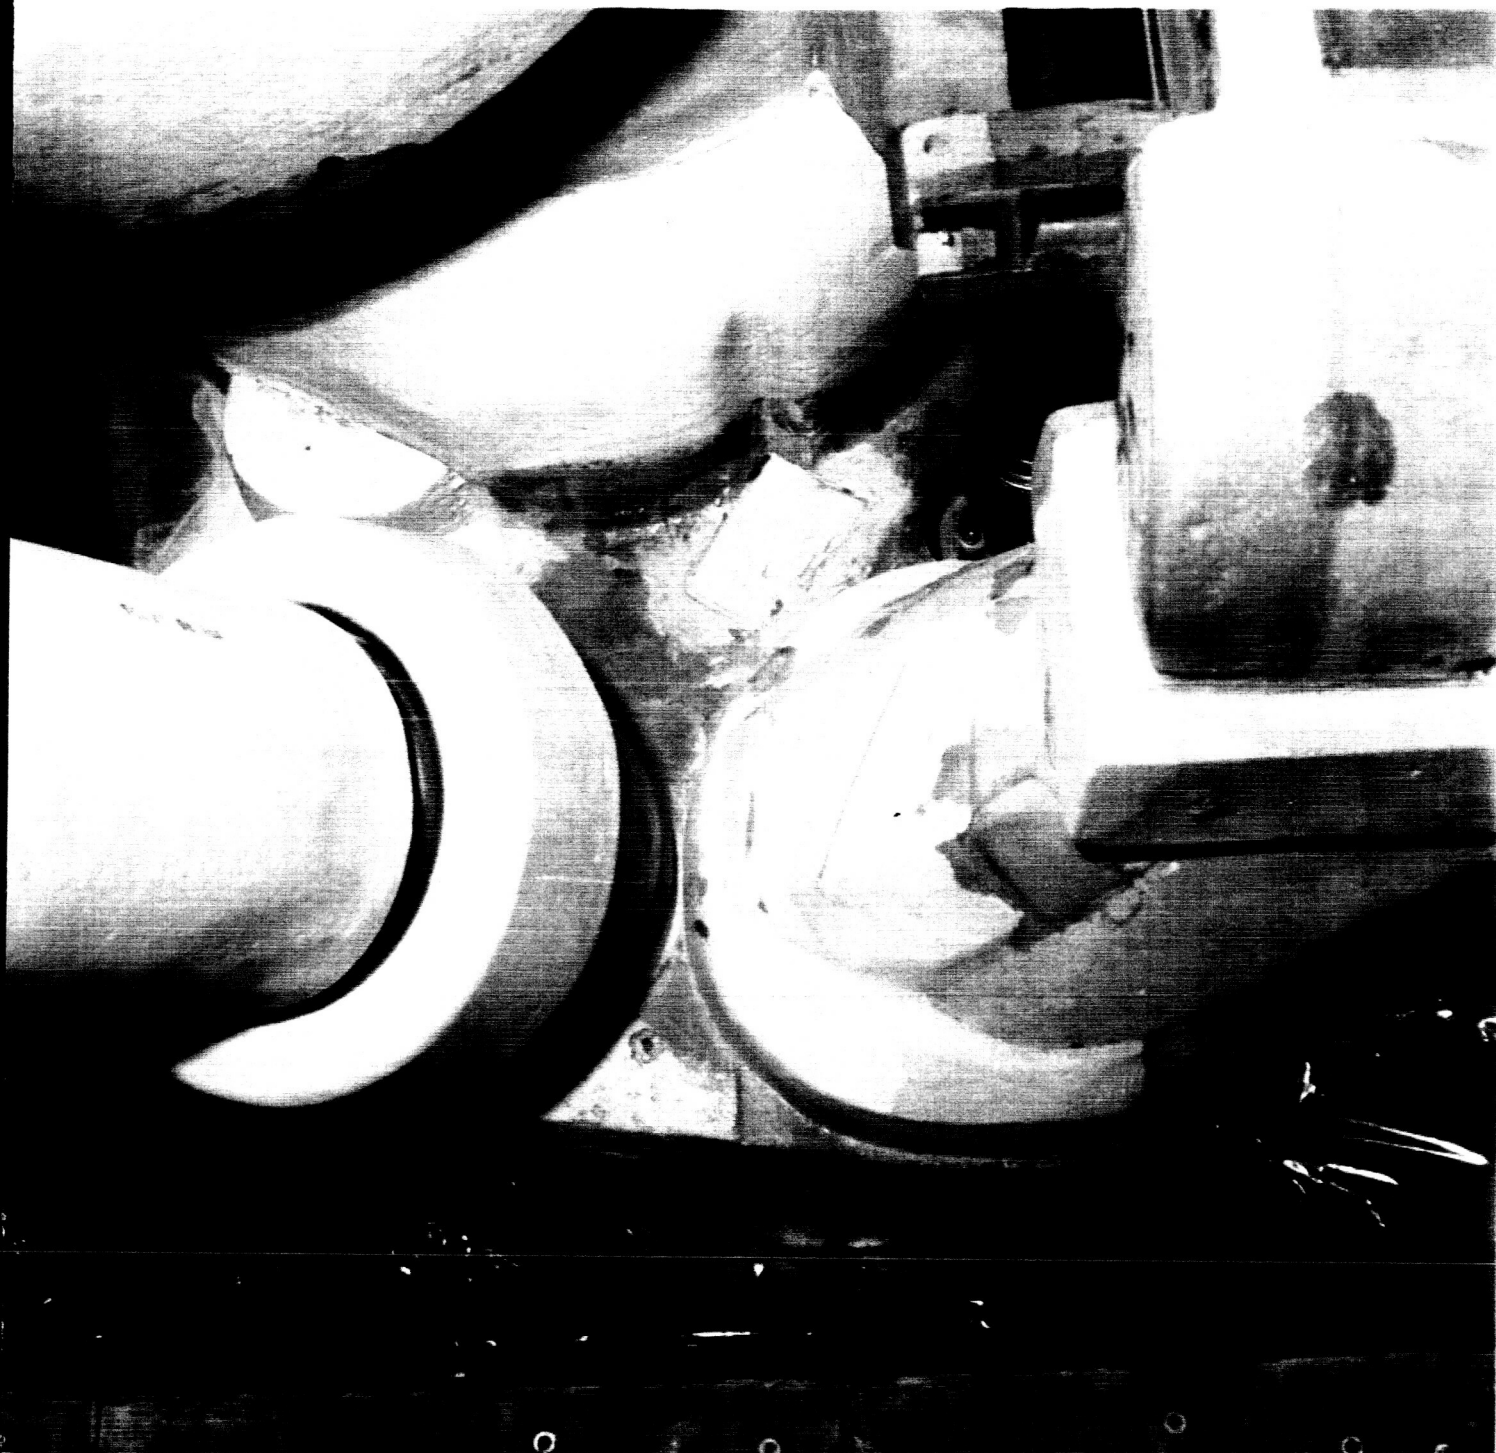
LH2 umbilical 17-inch flapper valve tool access port foam plug closeout appeared to have a small resin sealant void, or crack, at the top corner near the 17-inch LH2 feedline.

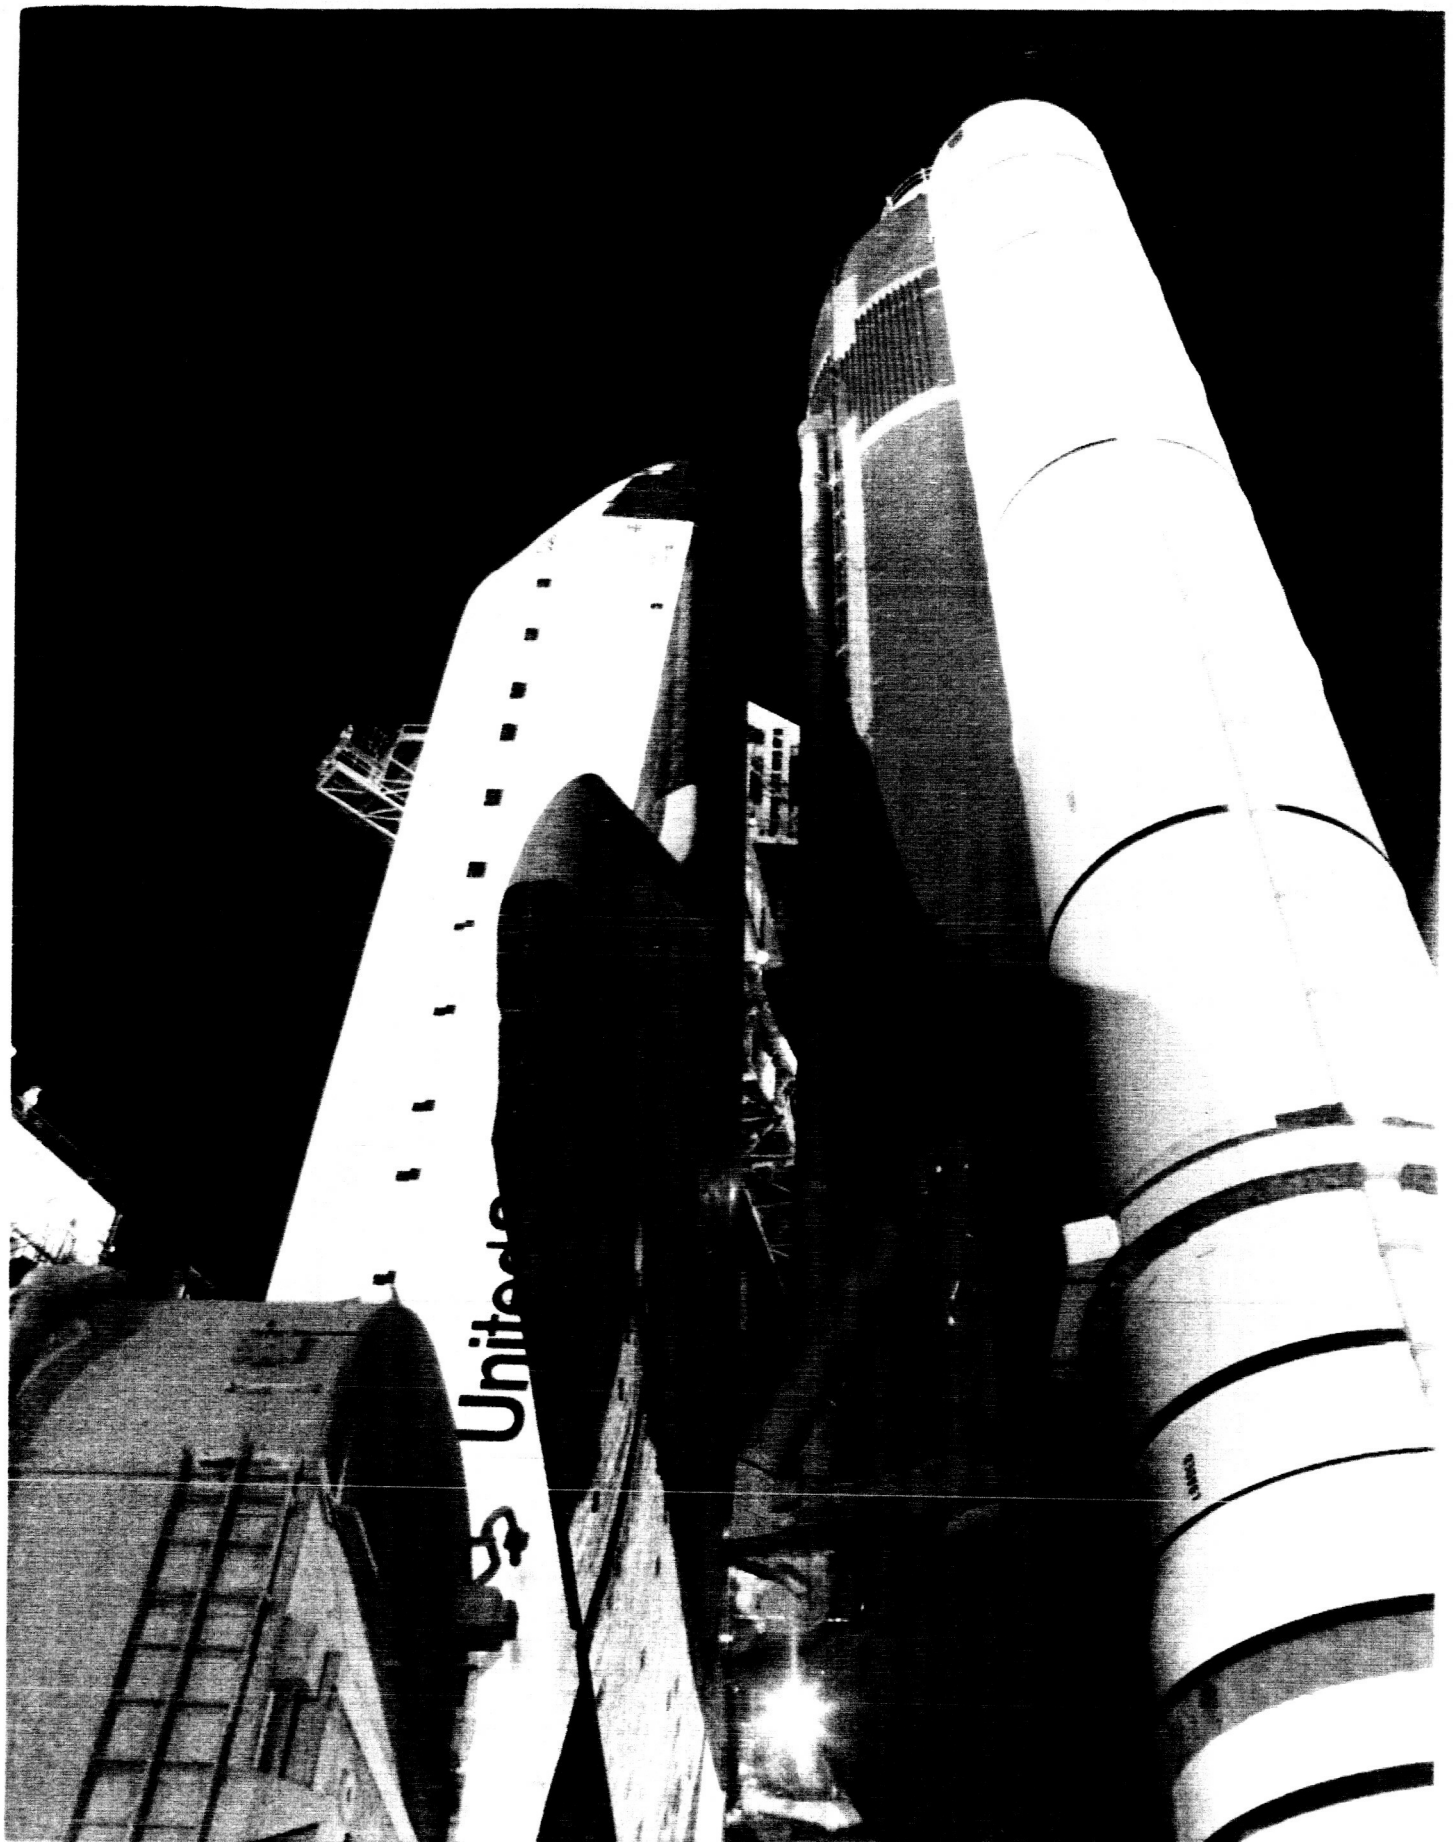
No ice/frost had formed on the LH2 tank and LO2 tank acreage.
Six frost spots are visible on the +Y longeron foam closeout.

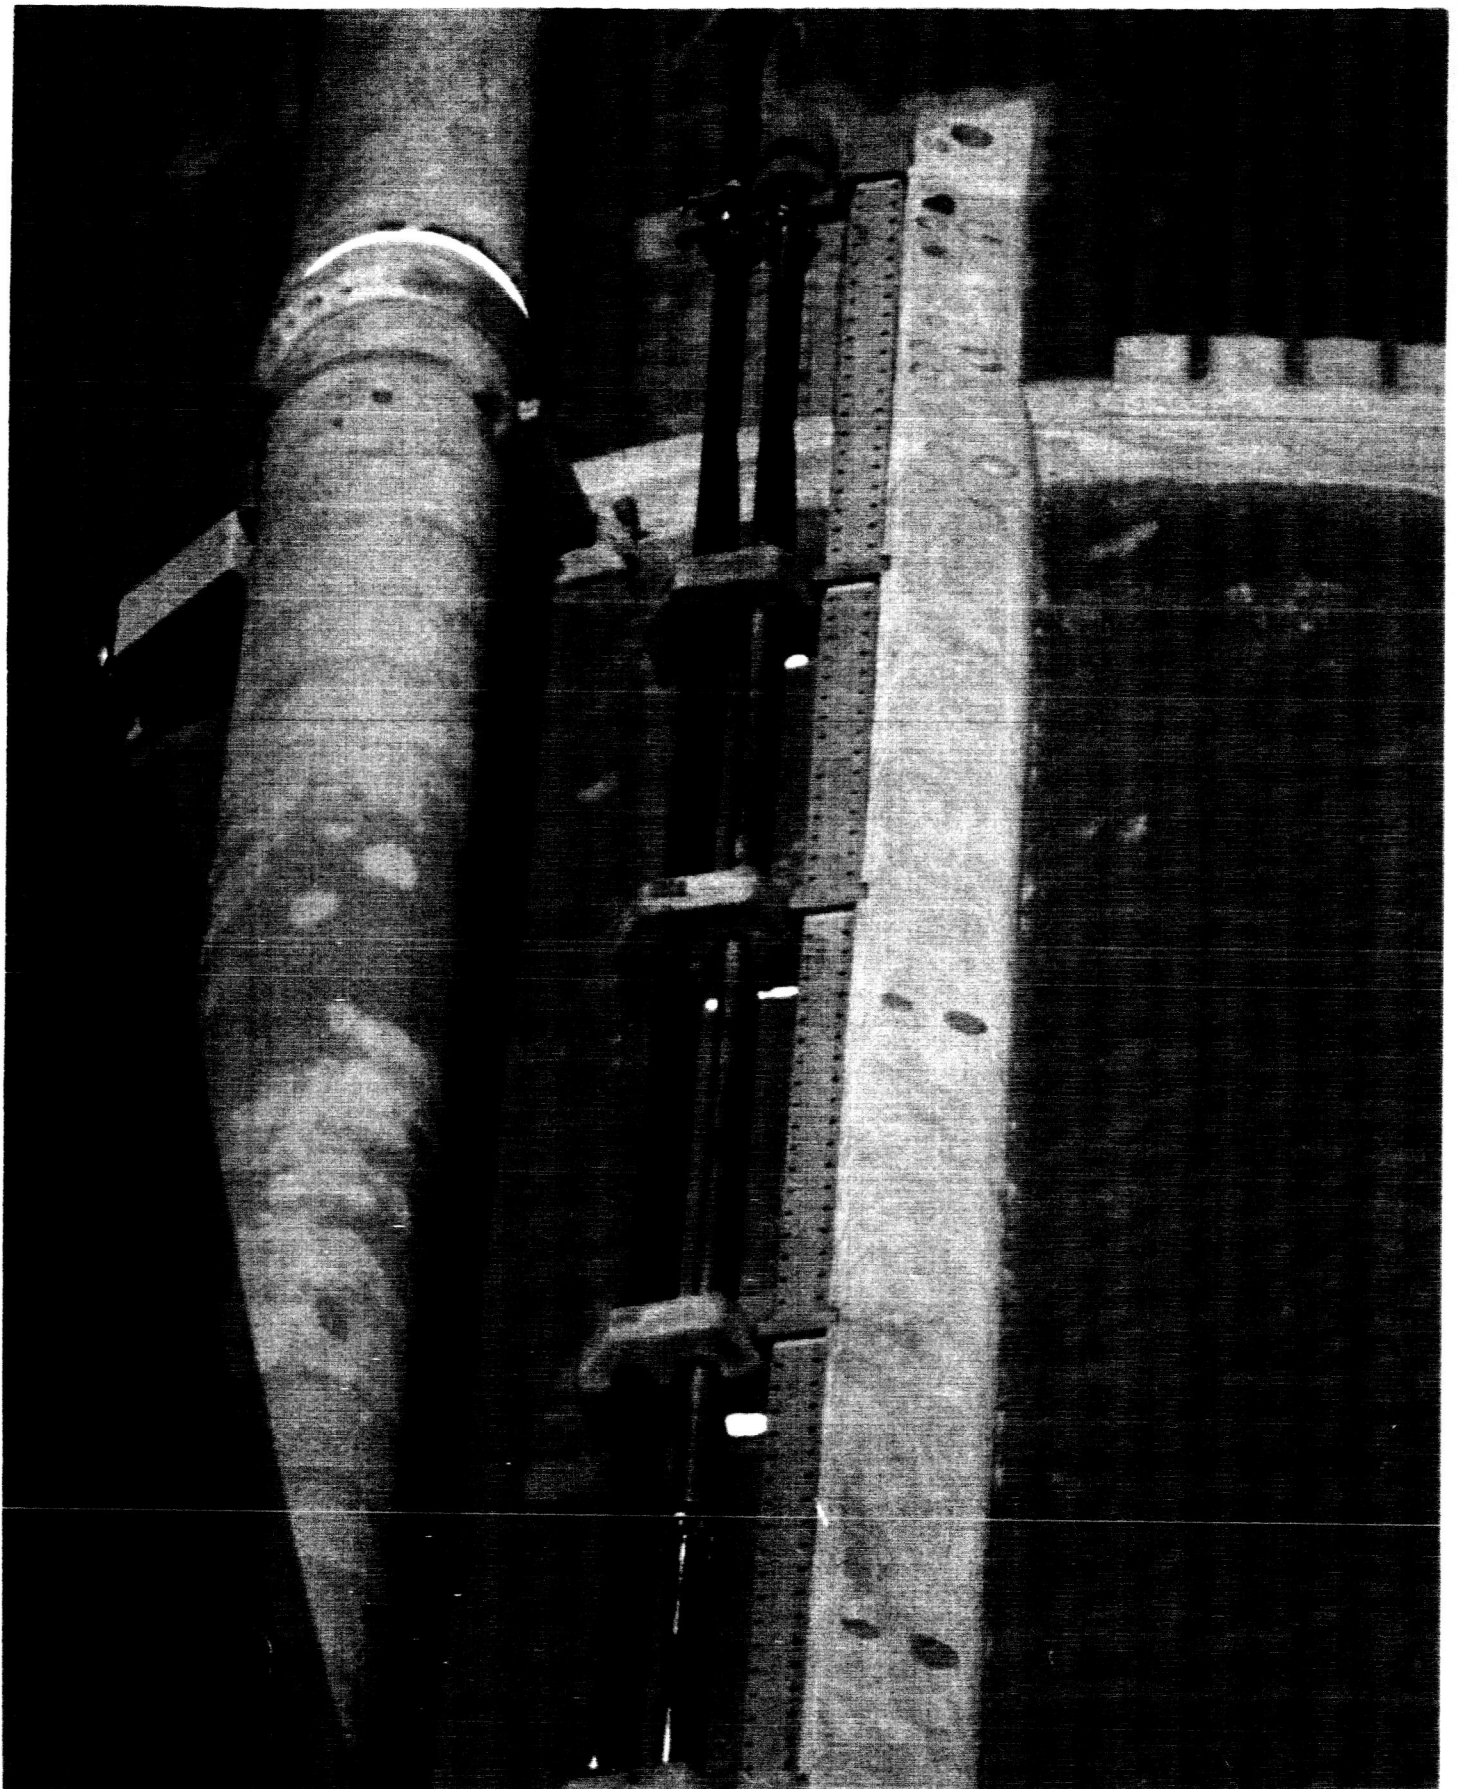
Normal amounts of ice were present in the L02 feedline upper bellows and support brackets. Ice/frost formations along the aft edges of the pressurization line brackets was acceptable for flight per the NSTS-08303 ice criteria document.

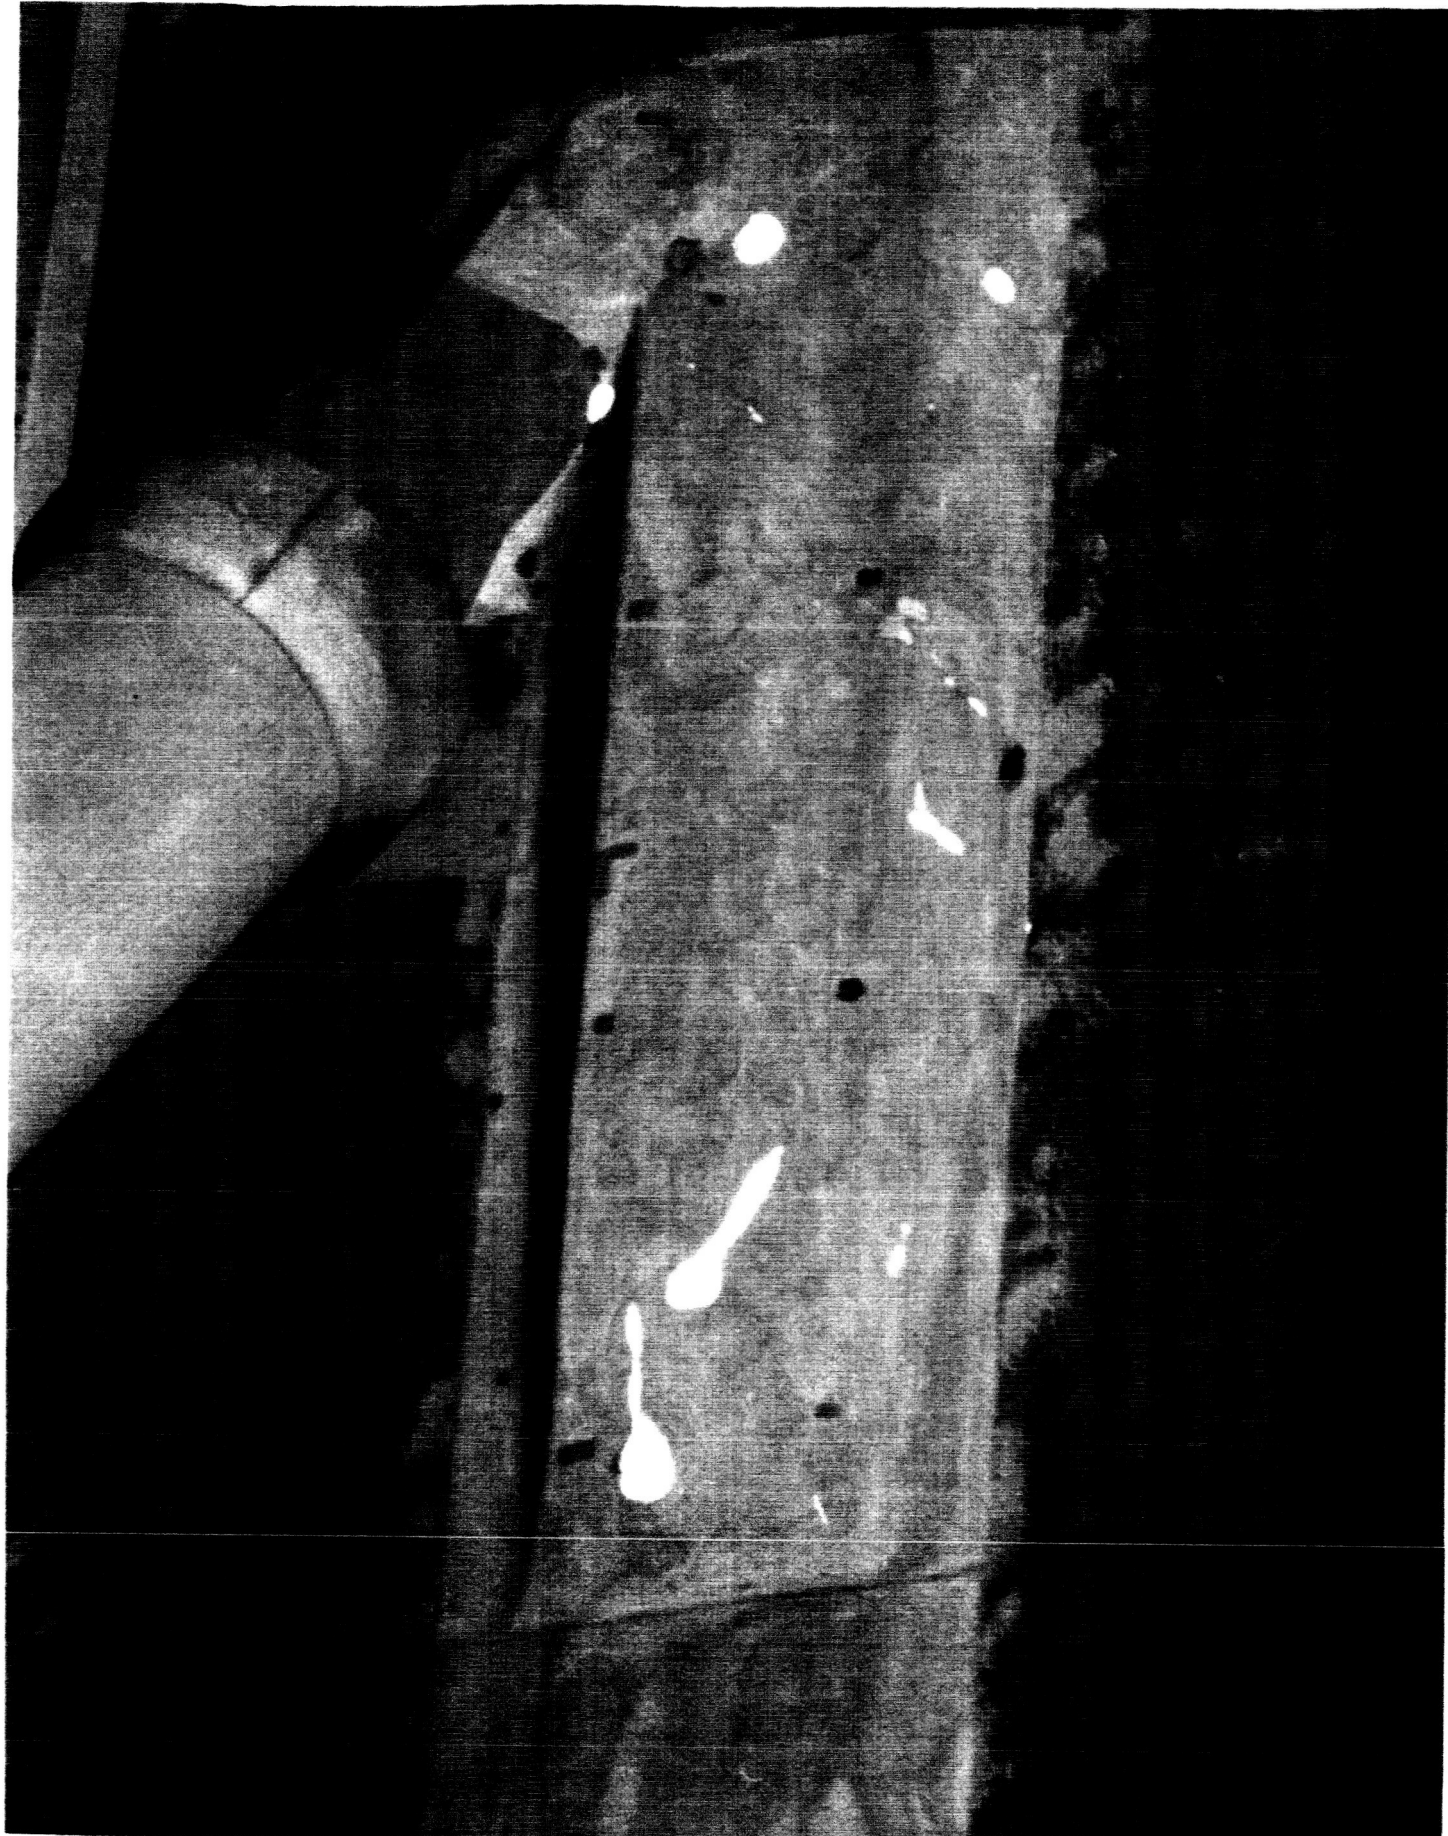
Ice/frost formations on the +Y longeron foam closeout and in the thrust strut-to-longeron interface were acceptable for launch per NSTS-08303.

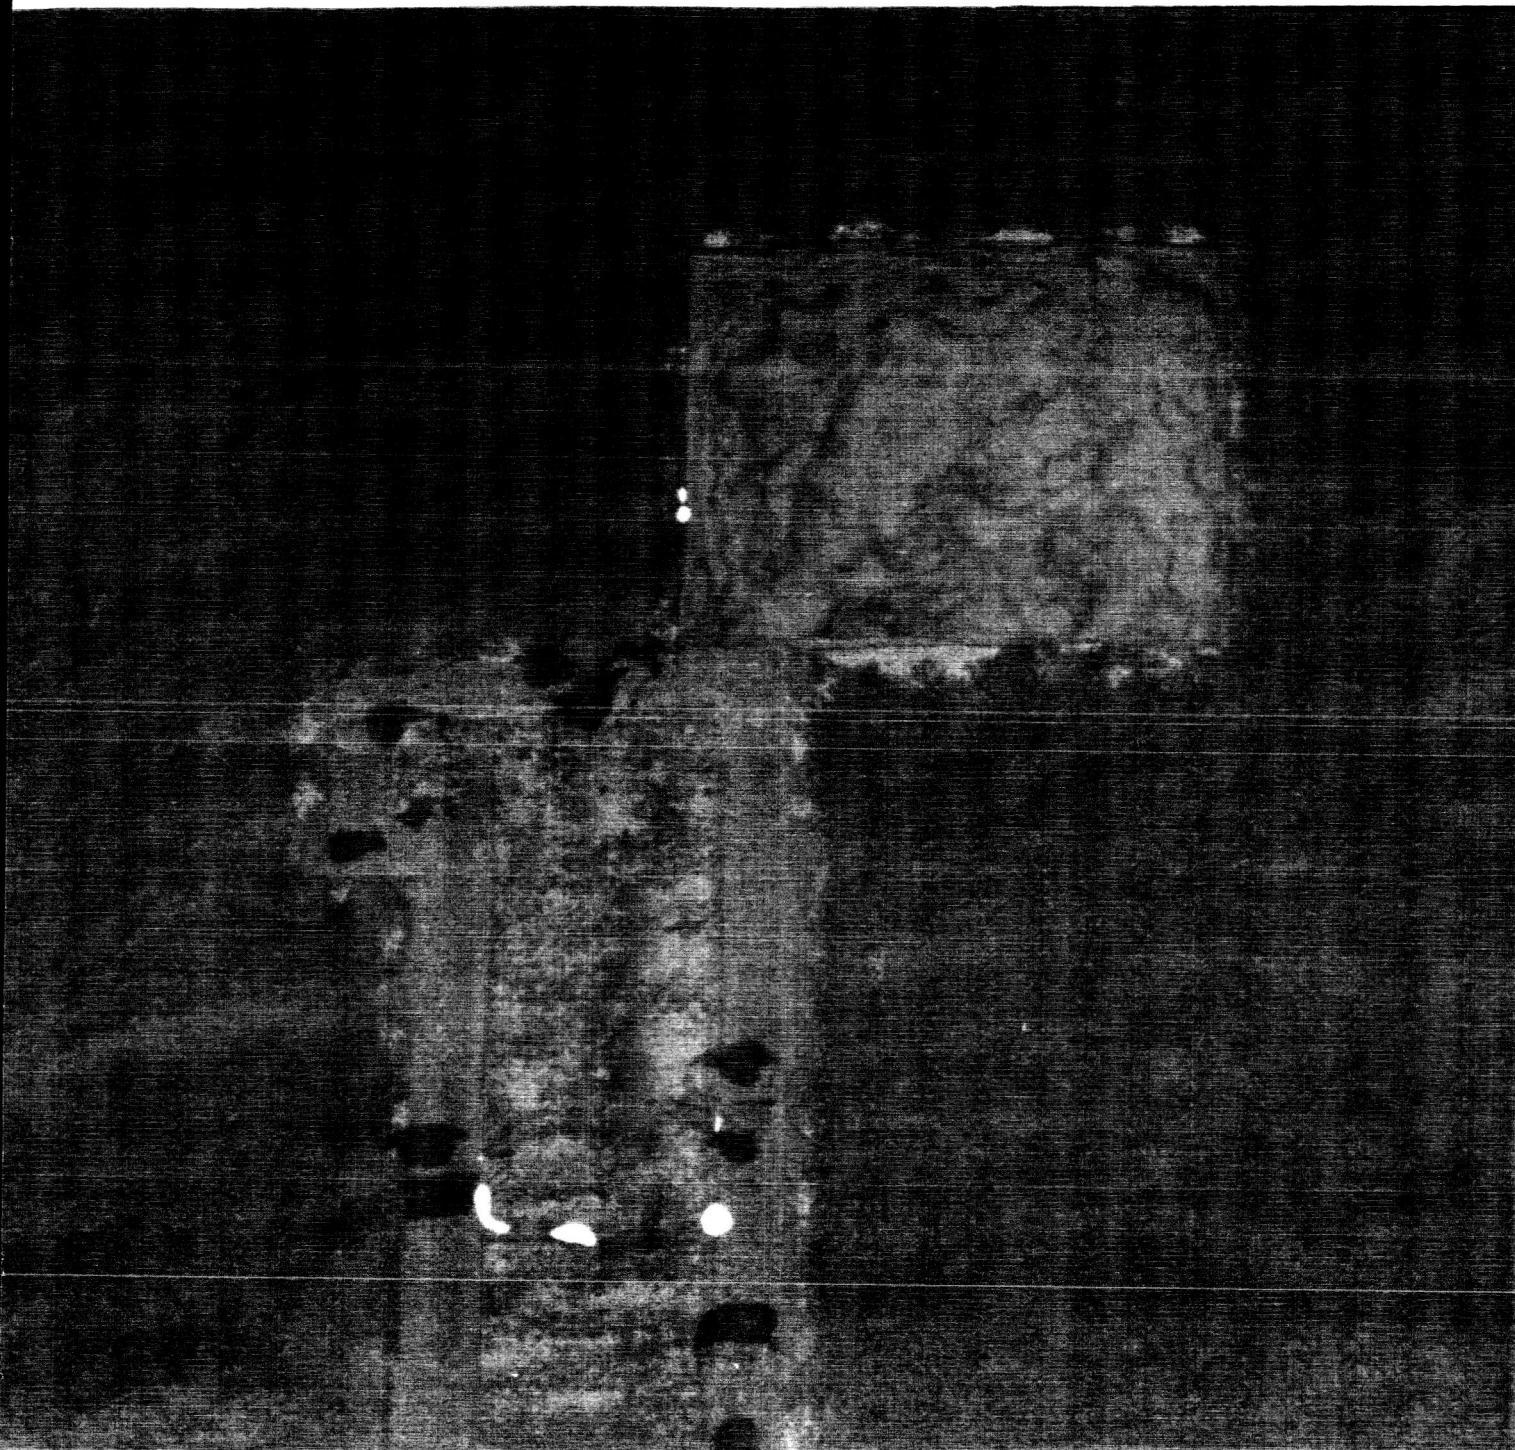
Numerous ice/frost spots appeared on the aft hardpoint closeout along the bondlines and knit lines - a condition acceptable for flight per the NSTS-08303 ice criteria.

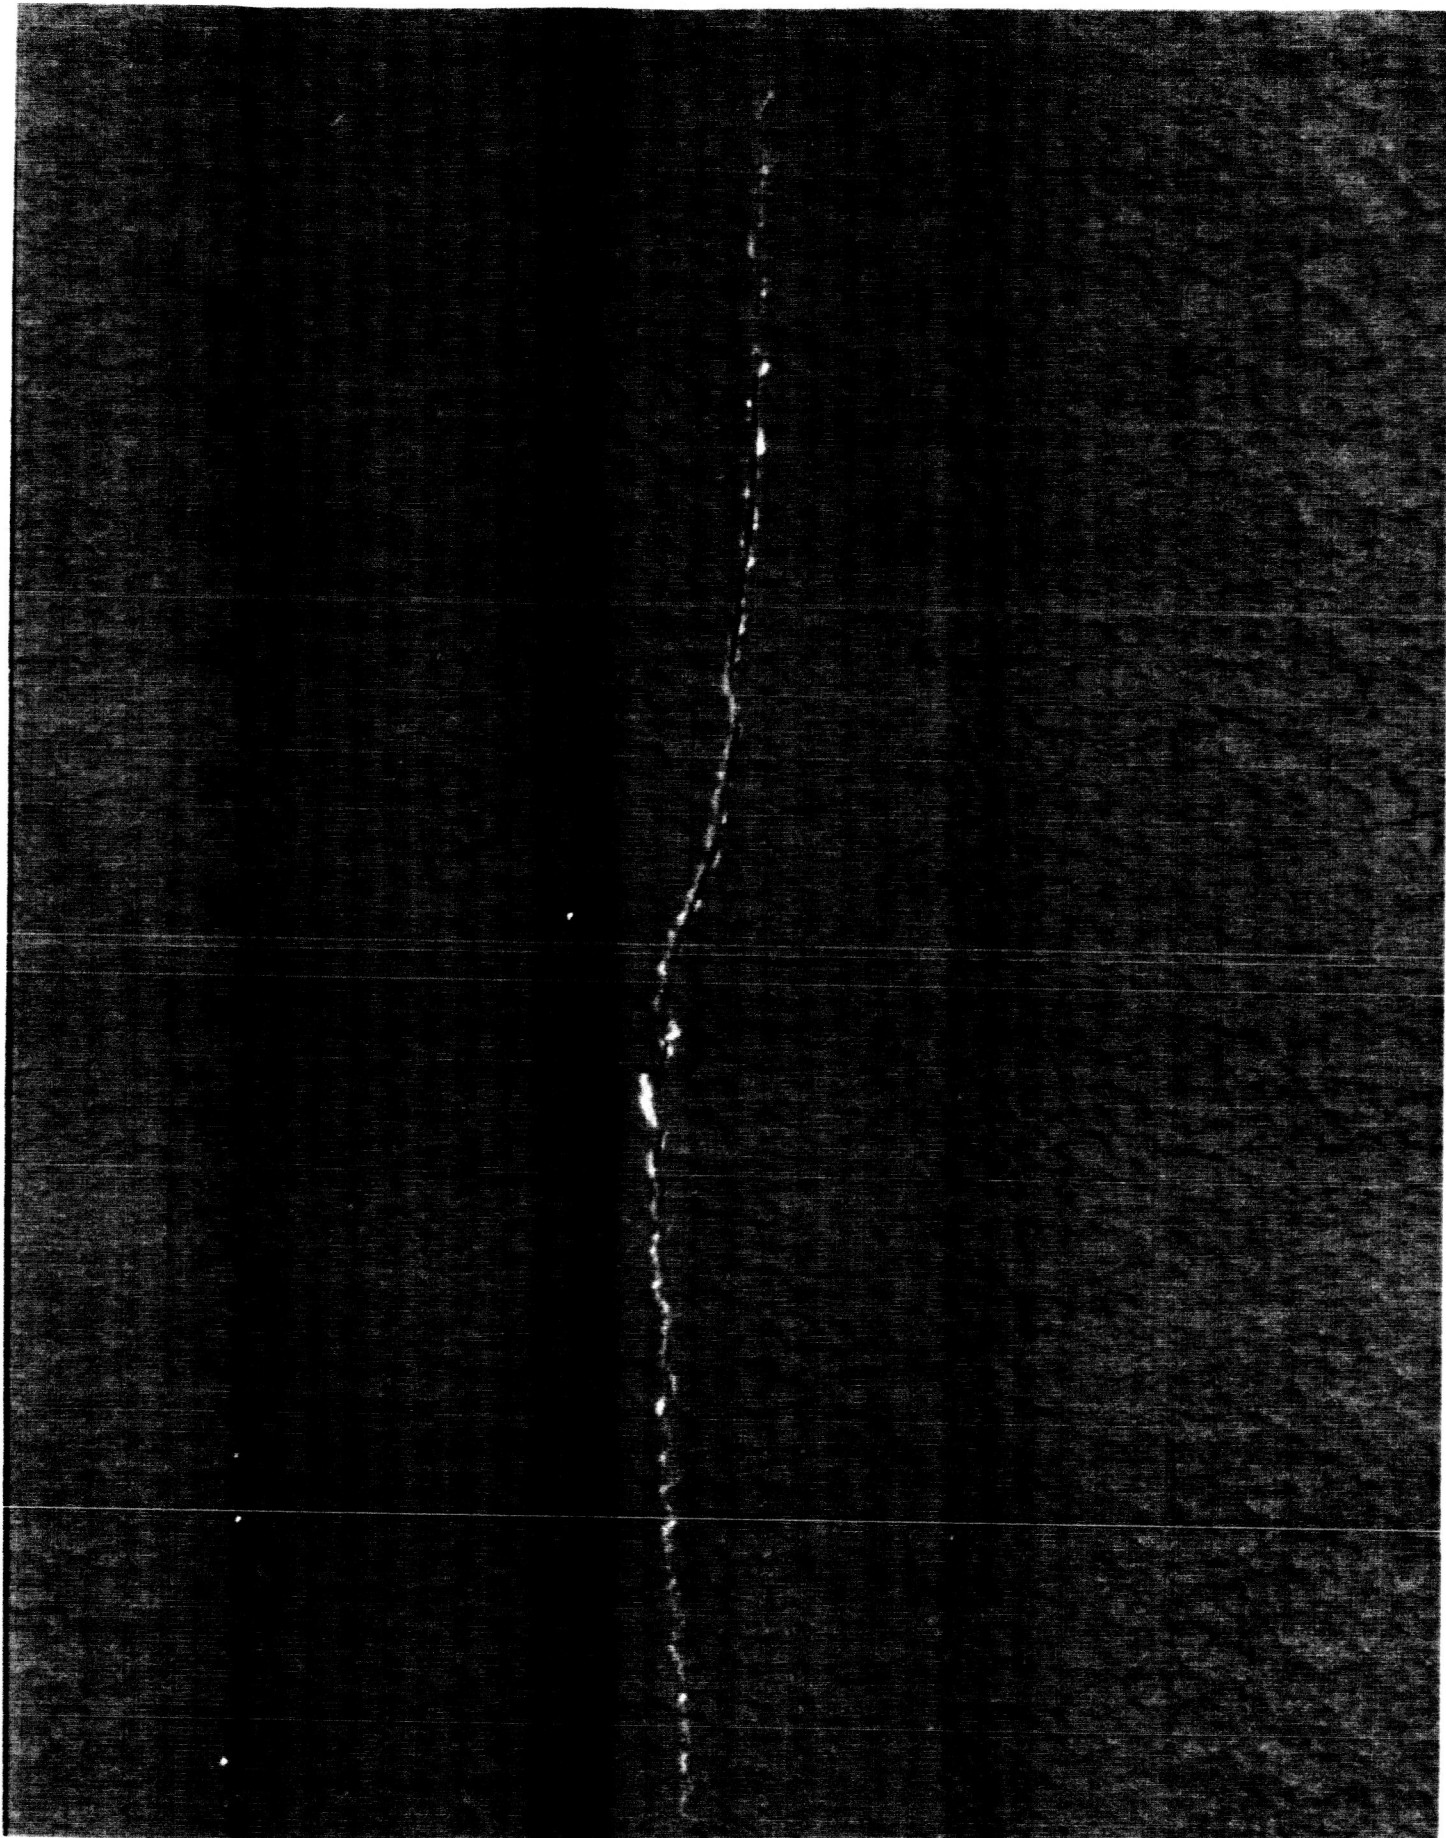
The crack was 1/4-inch wide, appeared to go to substrate, had no offset, and was not filled with ice or frost.

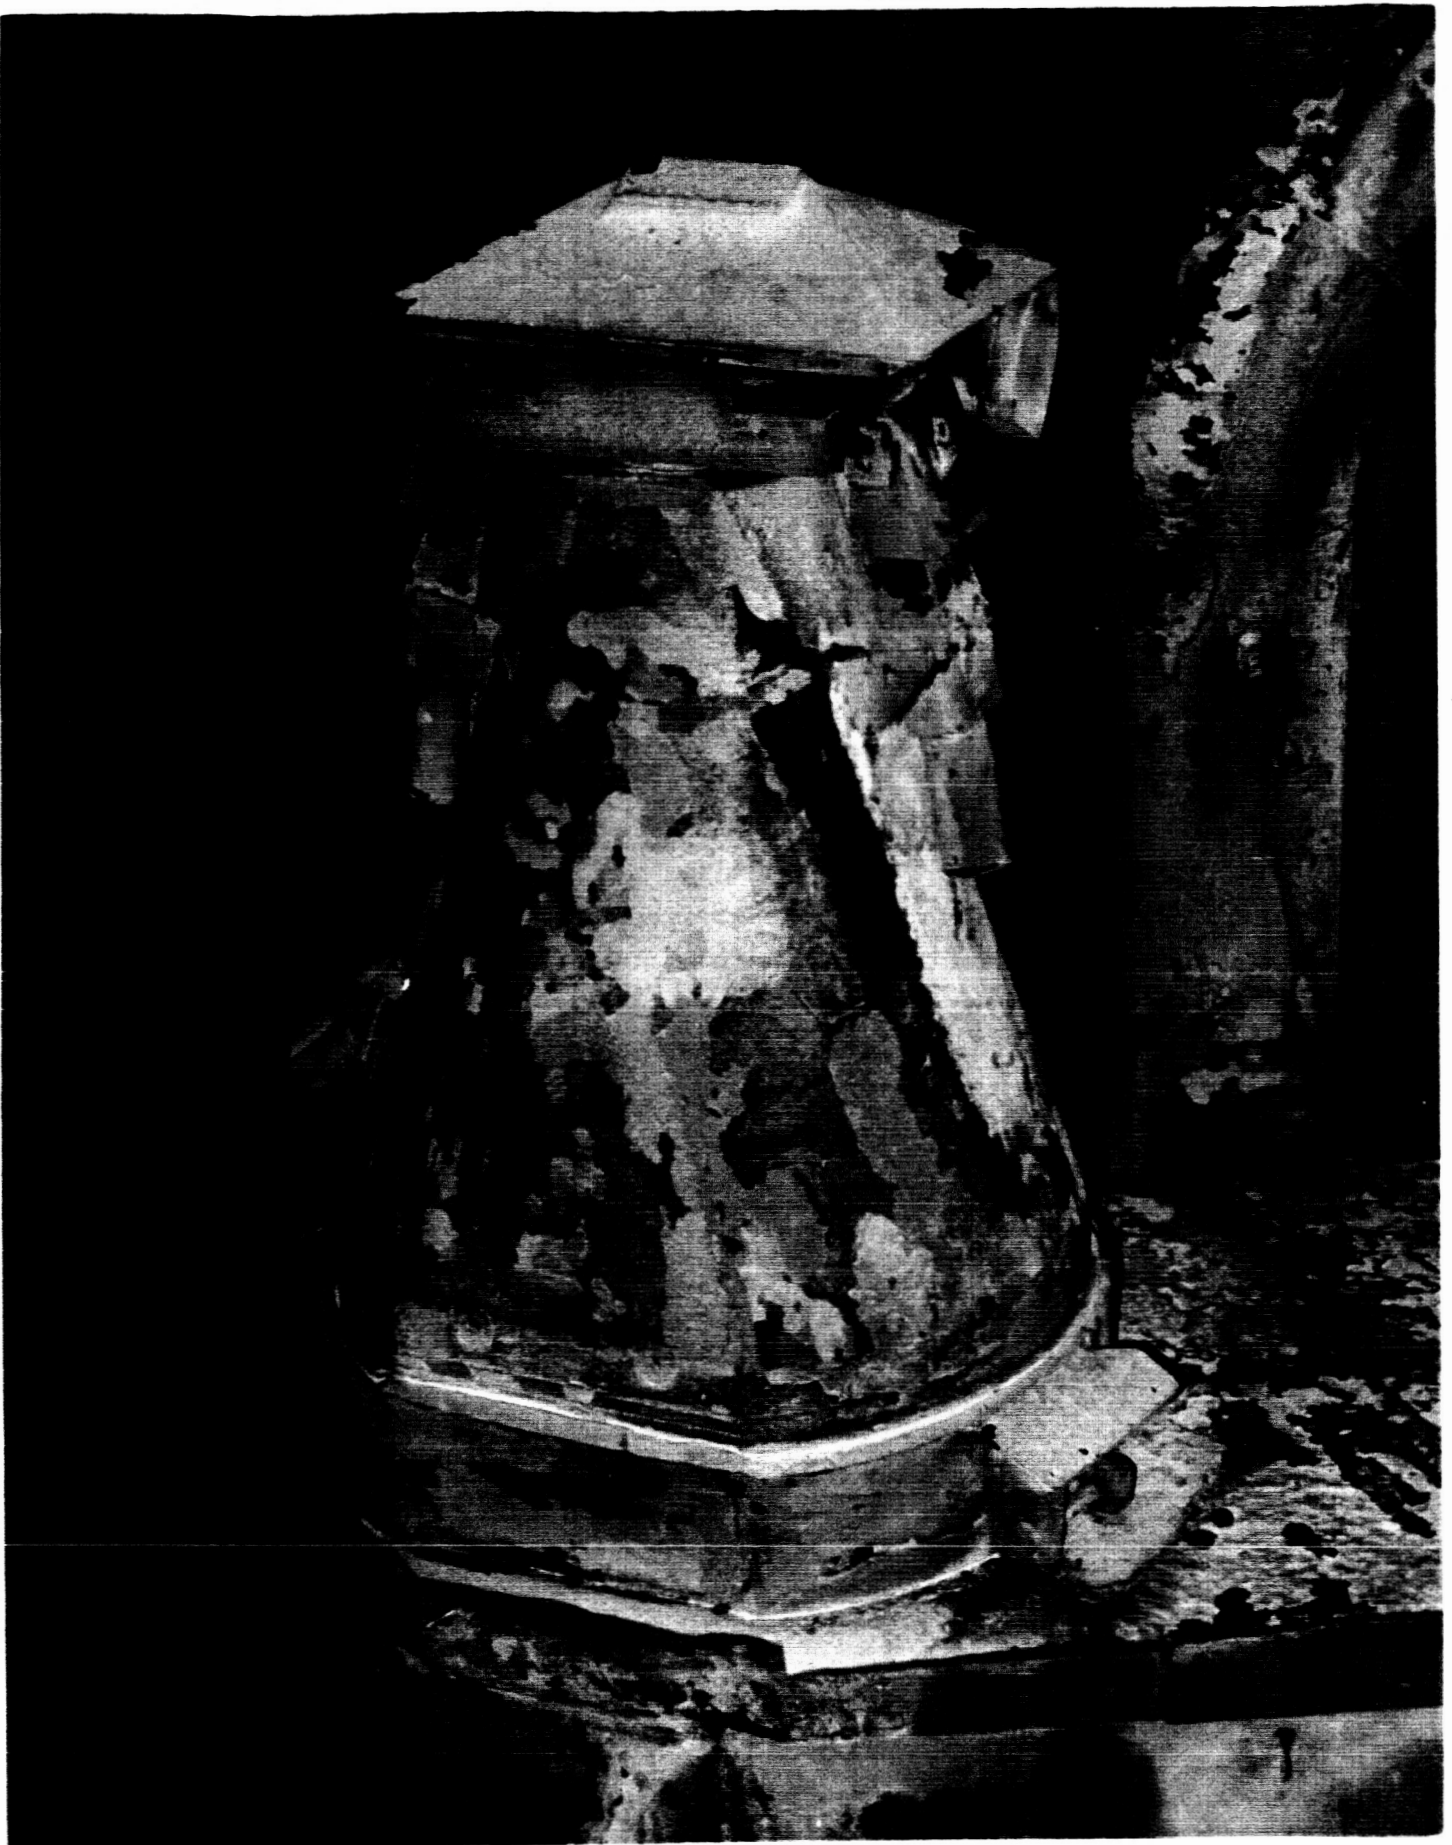
Typical post launch condition of north holddown posts. Doghouse blast covers had closed normally. Due to debris concerns, less RTV was applied to the bands around the holddown post bases.

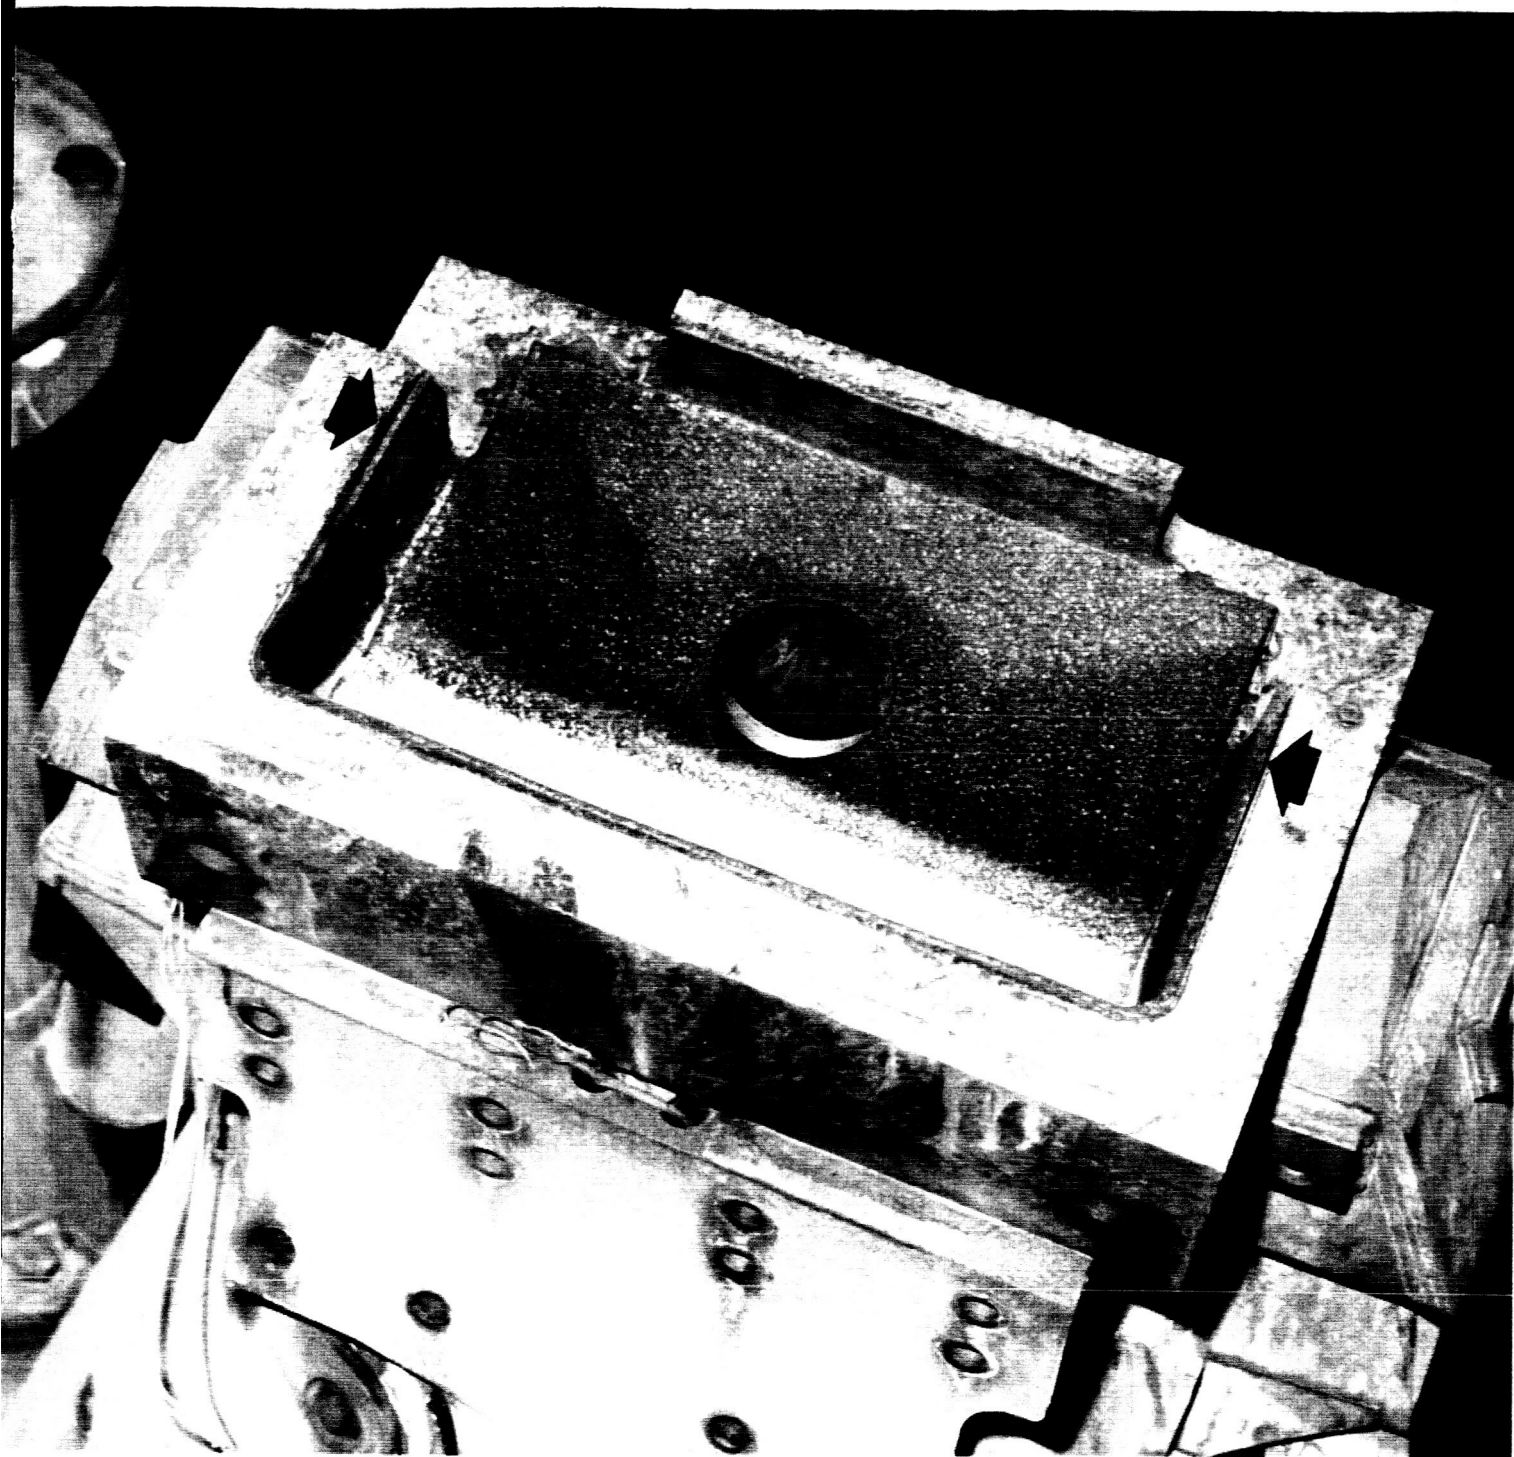
Typical post launch condition of south holddown posts.
Sidewall shim material debonded from the shoe is an anomaly.

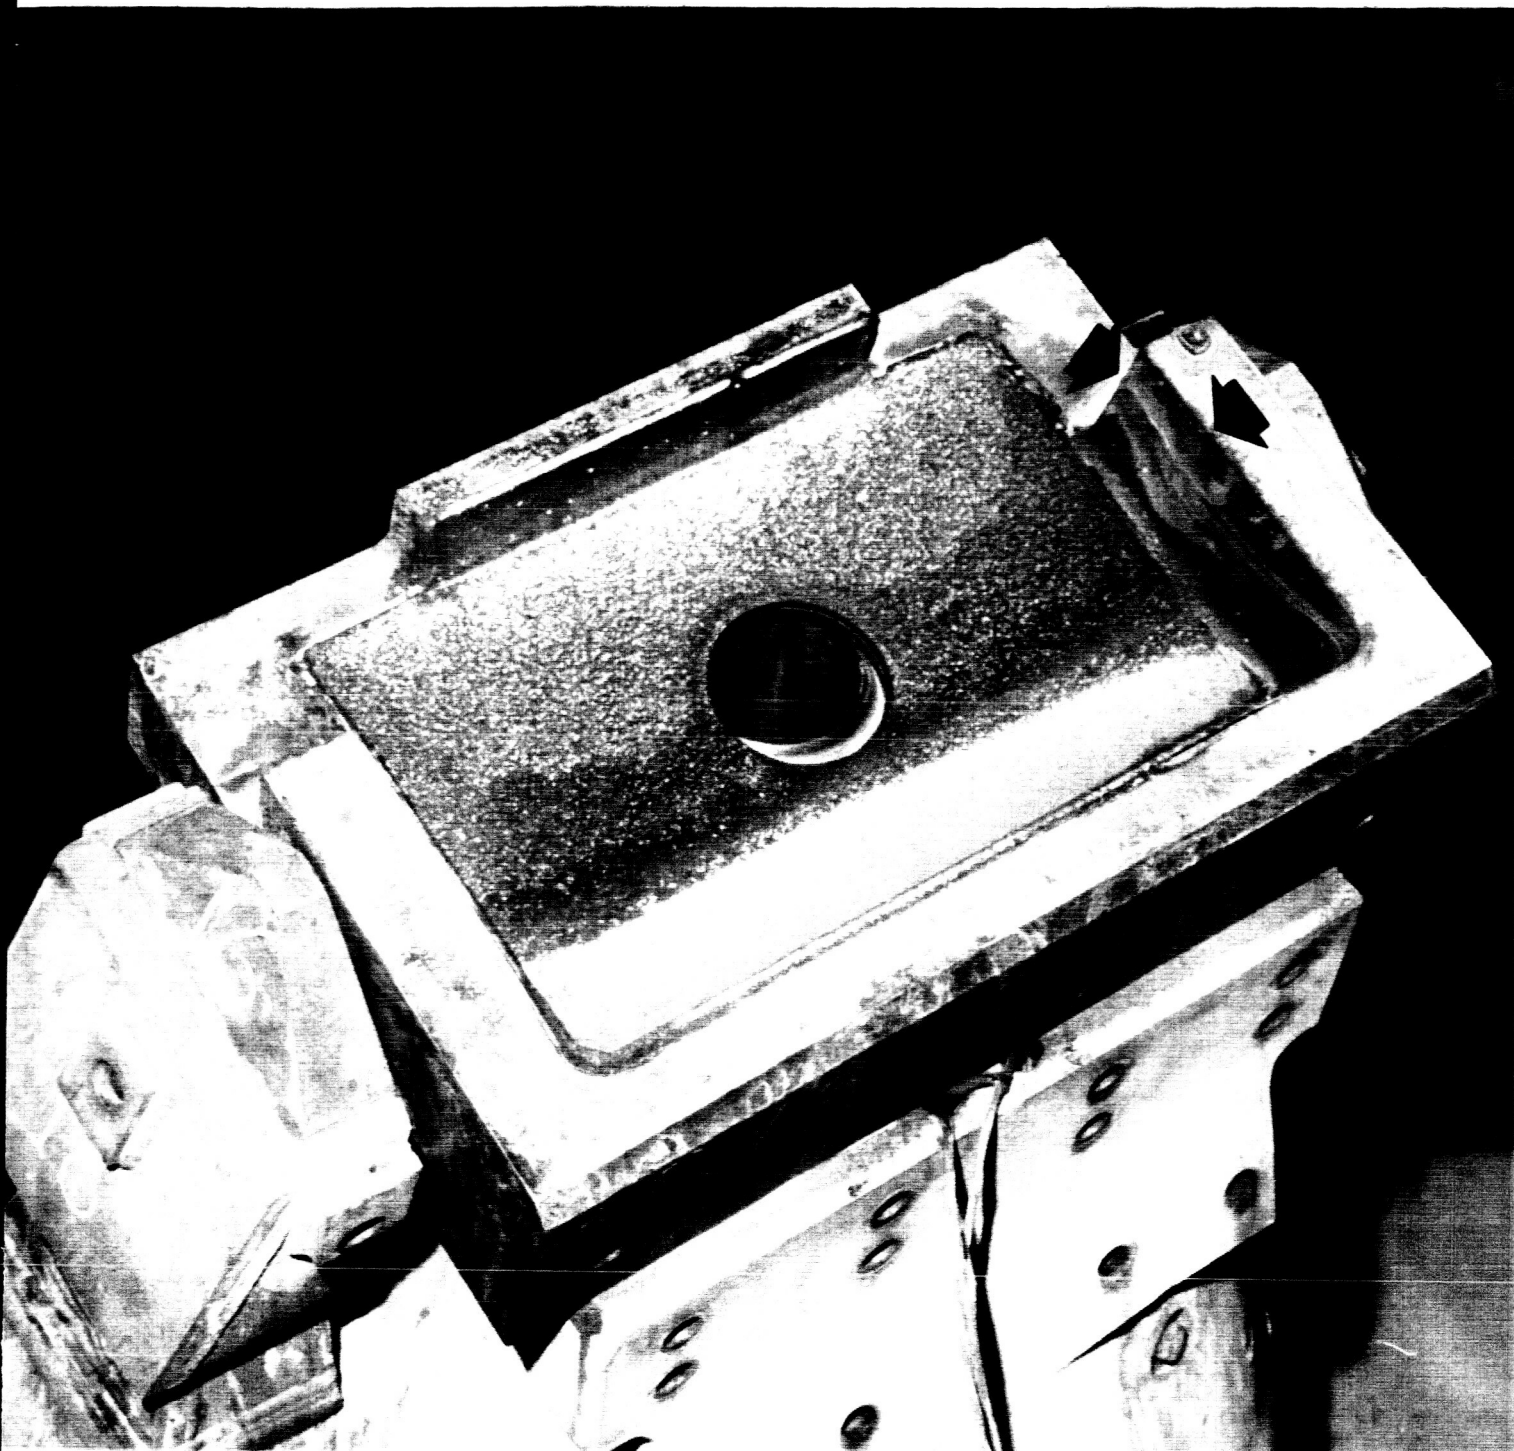
Two pieces of sidewall shim material, 10"x1" and 6"x0.5", were missing from holddown post #5 after launch
